Cargo Proa Prototype

Building Blog

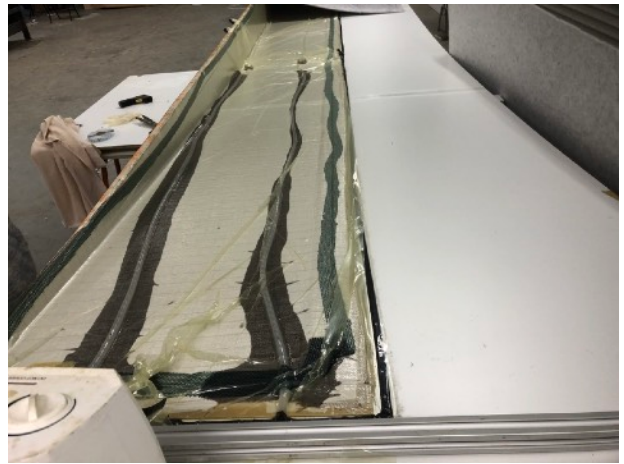
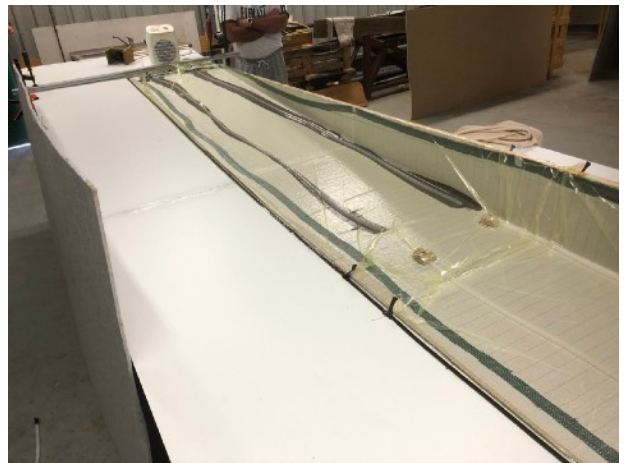
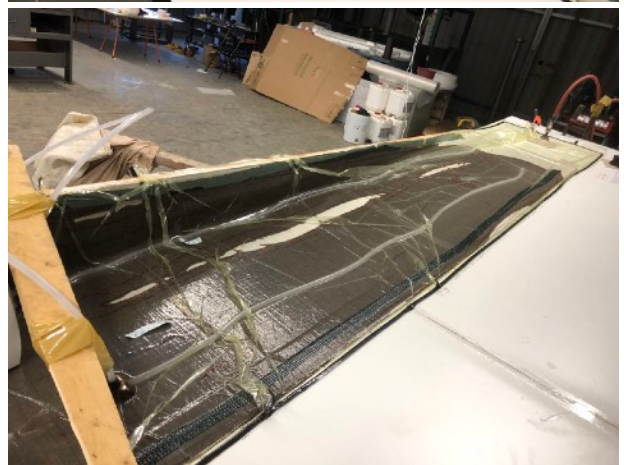
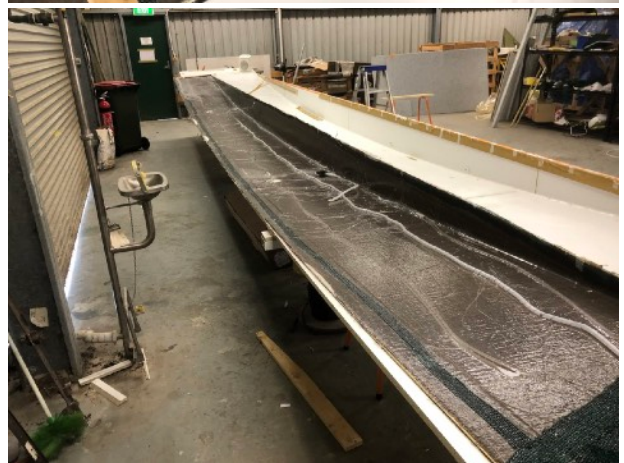
Repaired the dry spots by running a length of spiral across them and infusing. Not perfect but not far off. Photos show the extra length of spiral. Heated it, cut the materials for the next half hull then demoulded it. The plastic mould liner worked well. I should have plastic taped the mould edge but nothing a sharp chisel didn't fix. The vertical looks good, I can't lift it solo to see the horizontal surface.

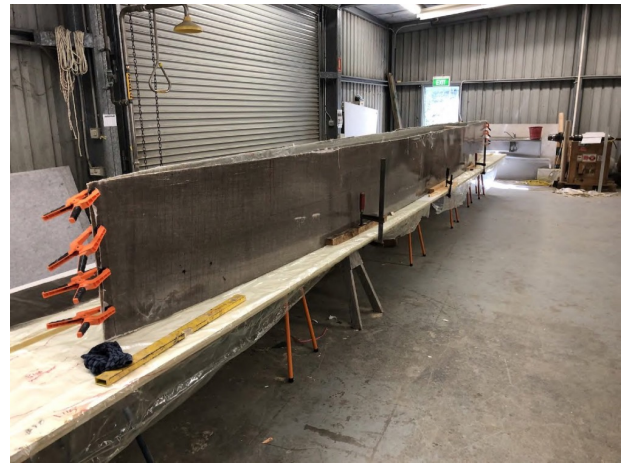
First hull joined

Glued the hull together. Remarkably quick and easy. Did some more test pieces, some successfully, some not so much. Prepped the other half hull for joining. Had a meeting with the other partners to discuss samples for testing and meet the engineer who will be doing the FEA stress analysis and laminate details for the beams, mast and hulls. Ordered some samples of an interesting 'eco resin' for testing.

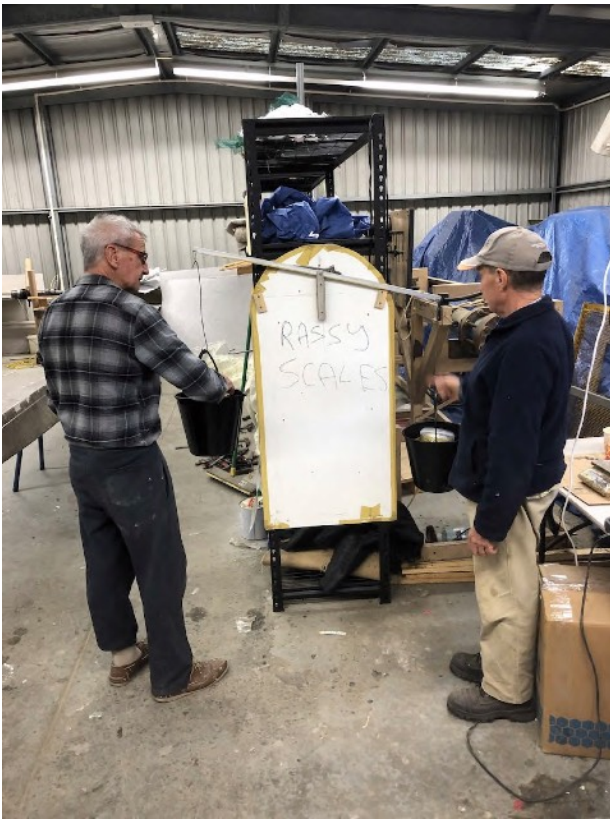
Rassy scale and balance weight. Simple and near idiot proof. One less thing to worry about during an infusion. Thanks Rob R.

Glass tow infuses easier than carbon. Laid out the third half hull. Female joins on both edges which made it finicky. Rob R made a cool set of scales which saves 500 bucks and made weighing much easier. "No glove" measuring and mixing (ie, no contact with the epoxy) is now reality, the resin bench is near(er) pristine and we can look at further fine tuning of the layout, heating and minimising materials.

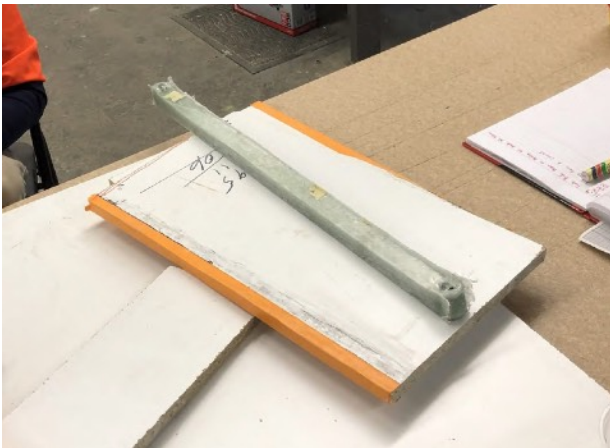
Truss beam sample

Beam sample infused (see pics) although far from perfect due to the inlet port losing contact with the spiral and an unexpected (as always) resin raceway developing. Will try a second infusion next week.

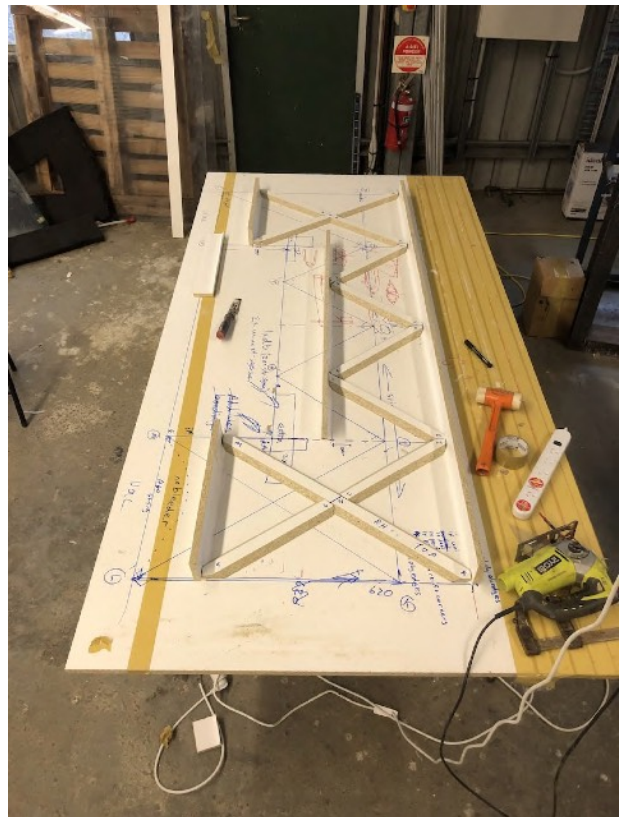
Foamless bulkhead ready for layup

Roan and I joined the other tender hull. Easier than the first one. Had an idea for a foamless bulkhead, should be ready to infuse soon.

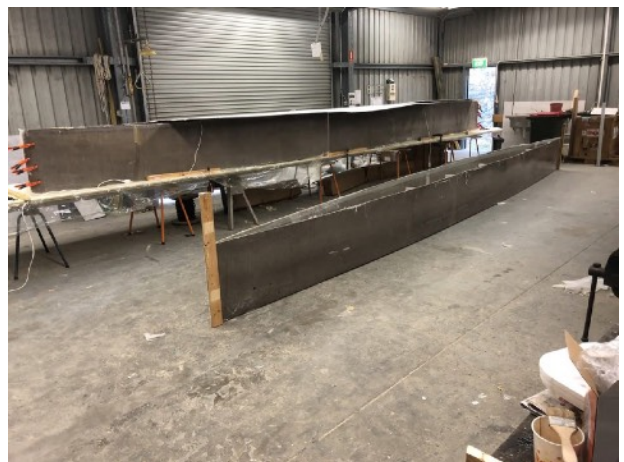
Both hulls joined

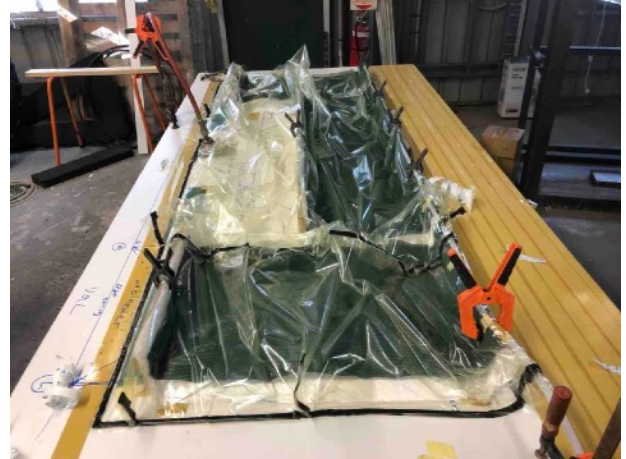
No foam bulkhead ready to infuse

Prepped the table for the tender floor, Rob R laid up the foamless bulkhead and Roan did some more tests, including a successful Soric one and a less successful tow in pvc one. He also serviced the vac pumps, which now work much better (more suck) and 3D printed an adaptor for the pump inlet. Handy guys to have around.

Rob R infused the bulkhead, looks good. Used a bit more resin (2 kgs vs 1.5) than expected, but there are a lot of places for it to hide. Will see tomorrow. The 1st half of the tender floor is ready to go when the pump is available. There are 4 components that require a wide table (ww hull sides, tender floor and deck). Decided it is less work to build them in halves and join them rather than extend the table. Plus the joins are all in the floppiest part so will act as stringers. Another test piece seeing whether perforated plastic between 2 layers of 6 x 400 uni would work. It does. We will probably lay up both deck halves in one shot, possibly also the ww hull halves. Volunteer insurance is apparently sorted, should have a few more workers soon. Weighed one of the tender hull shells: 50 kgs/110lbs. Not bad, on course for <150 kgs all up.

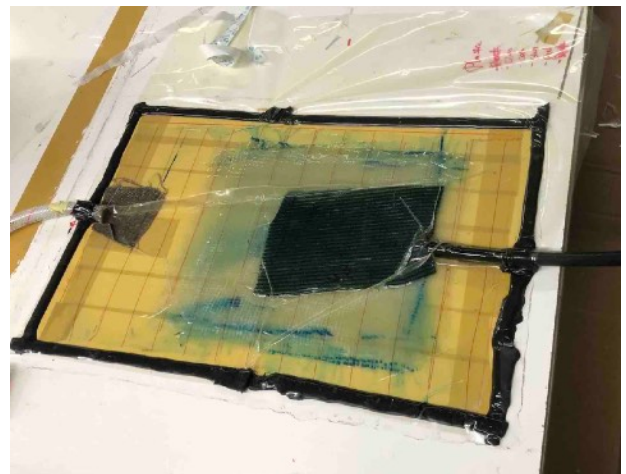
10 layers of 400 with perf plastic

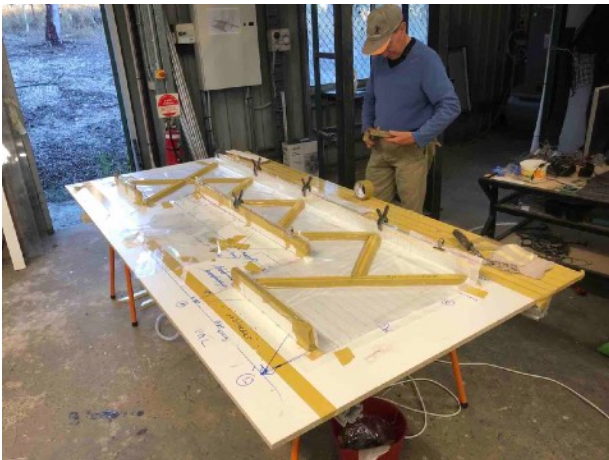
No foam bulkhead ready for cloth

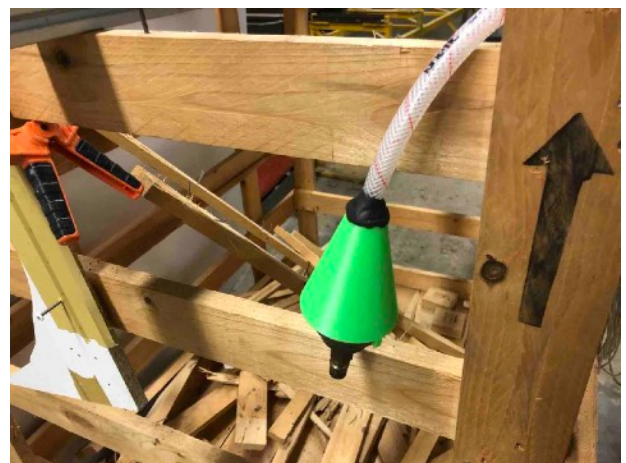
3d printed adaptor

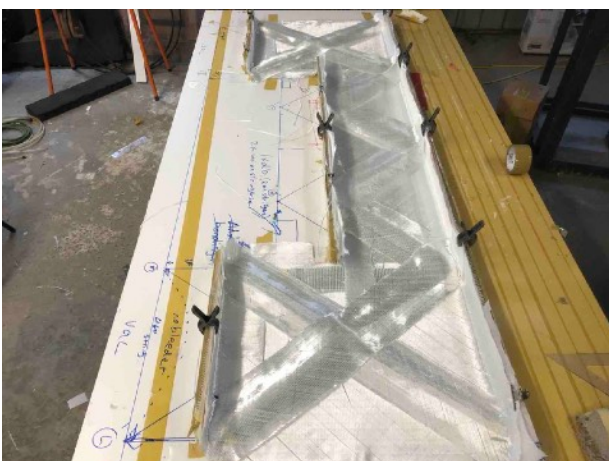
No foam bulkhead ready for plumbing

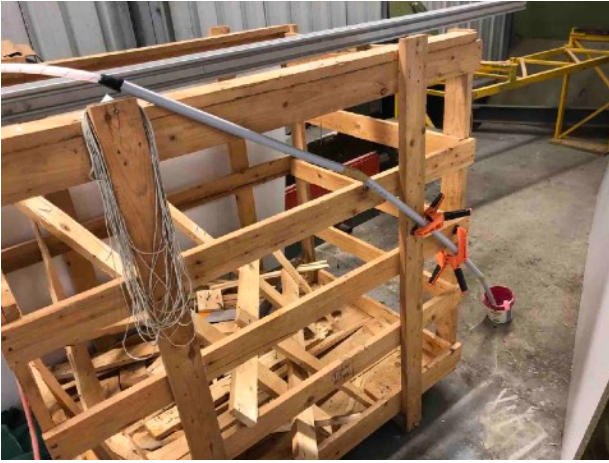
Tow infusion test
