# C60 - Peru

## Building Blog 2016

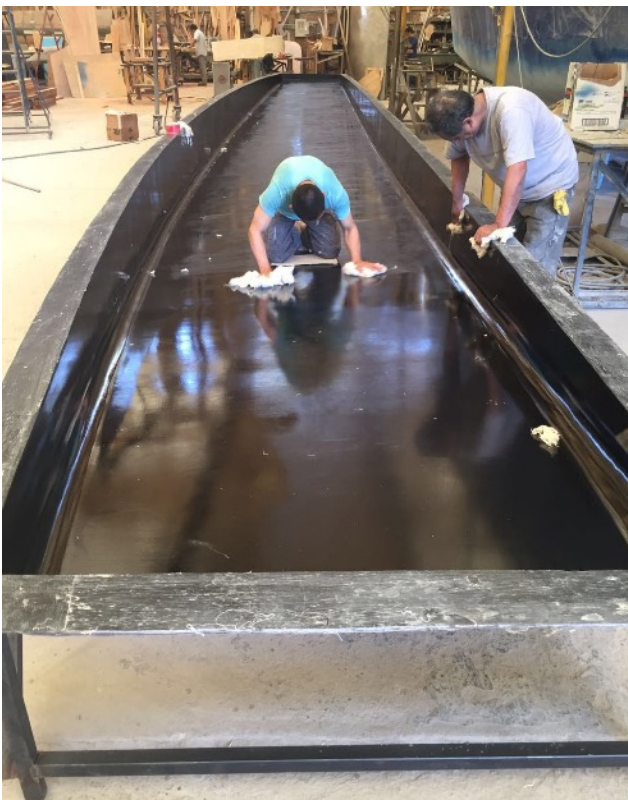
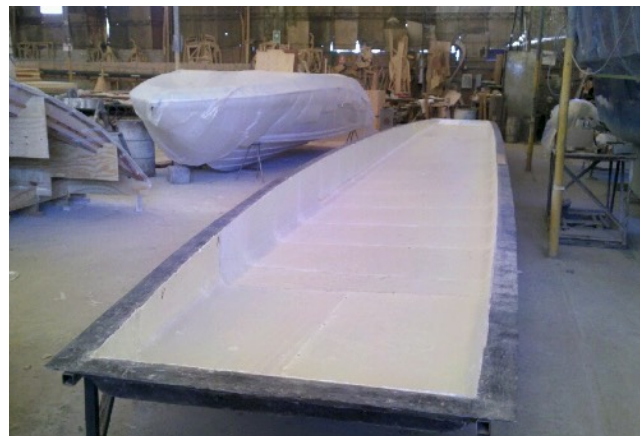
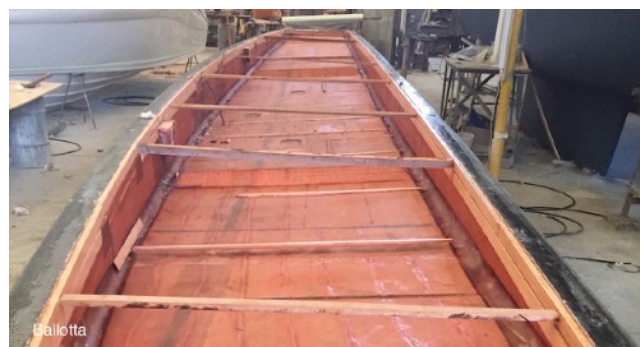
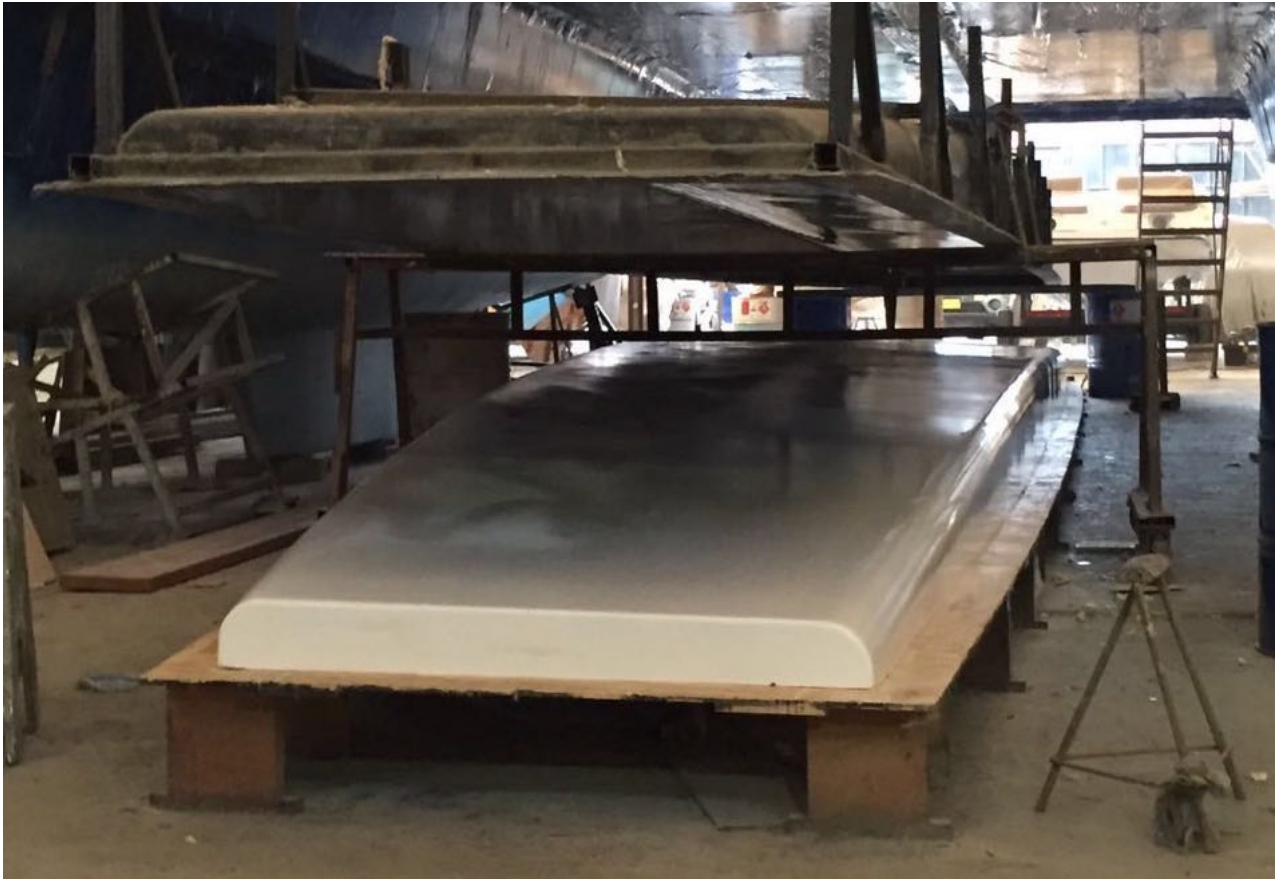
The owner and the builder decided there could be a market for these boats so built a “normal” plug and mould instead of the mdf mould in the plans. Added some time, but will certainly pay off for future boats. The crew at Ballotta started laying out the materials for half the lee hull and decks a week ago. Took 2-3 days to cut it and lay it all in place and a couple of hours to infuse it.

Bit of a hiccup getting vacuum which was caused by a misunderstanding, but once that was cleared up, it went without a hitch. Giorgio has made a couple of suggestions, which we will include in future plans.

Next step is making and bonding in the bulkheads, and the furniture, then demould it, lay up the other half, which includes the rudder cases beefing up (14 layers of 600 db/18 oz glass) and glue the 2 together.
