C60 - Peru

Building Blog 2017

The lee hull of the C60 was joined last week.

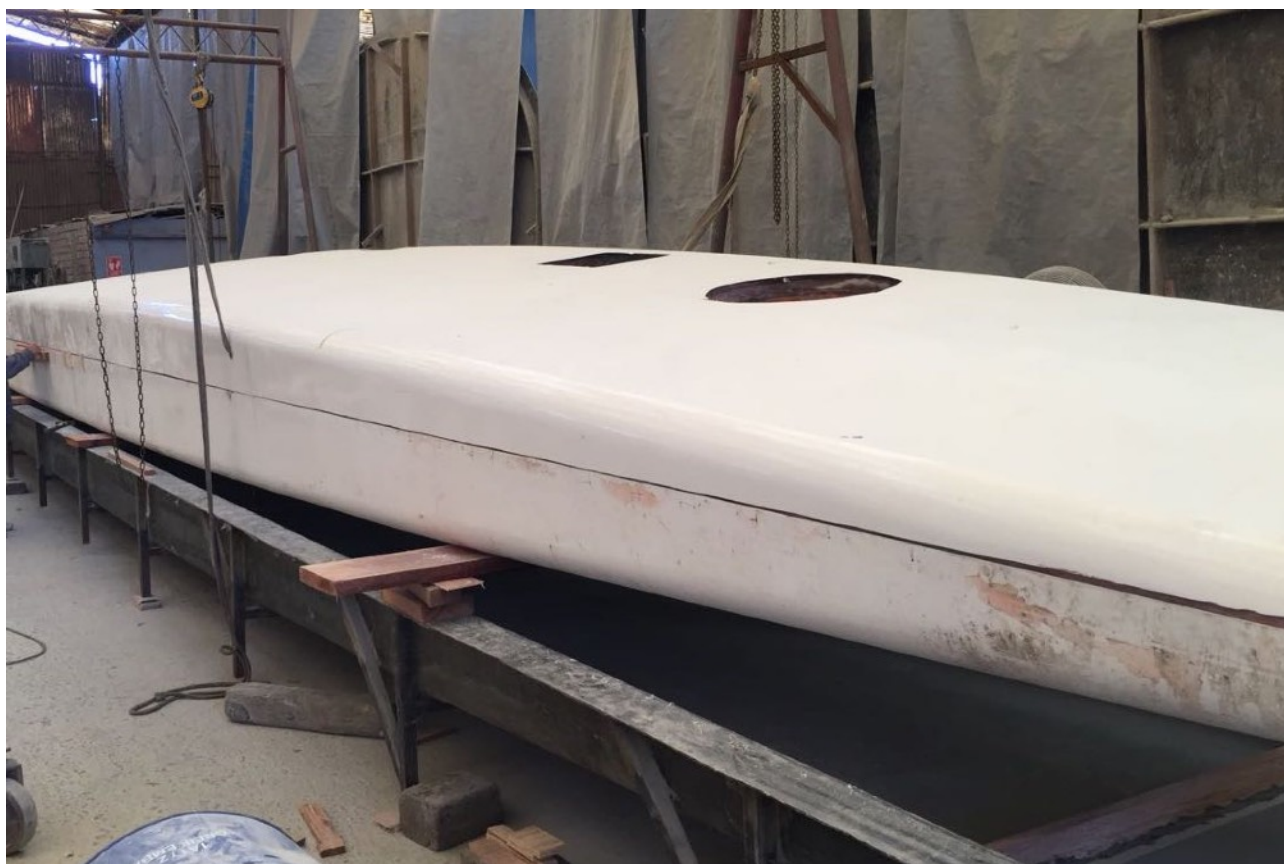
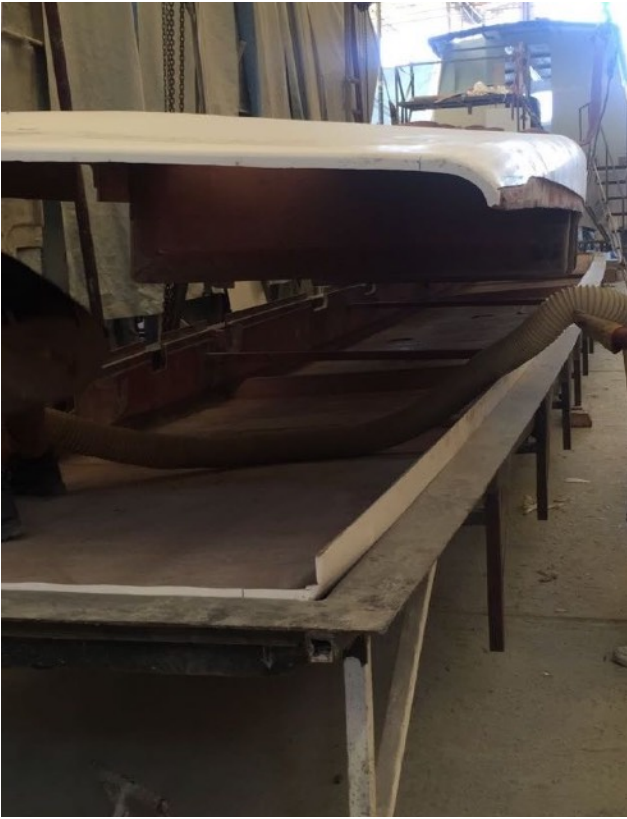
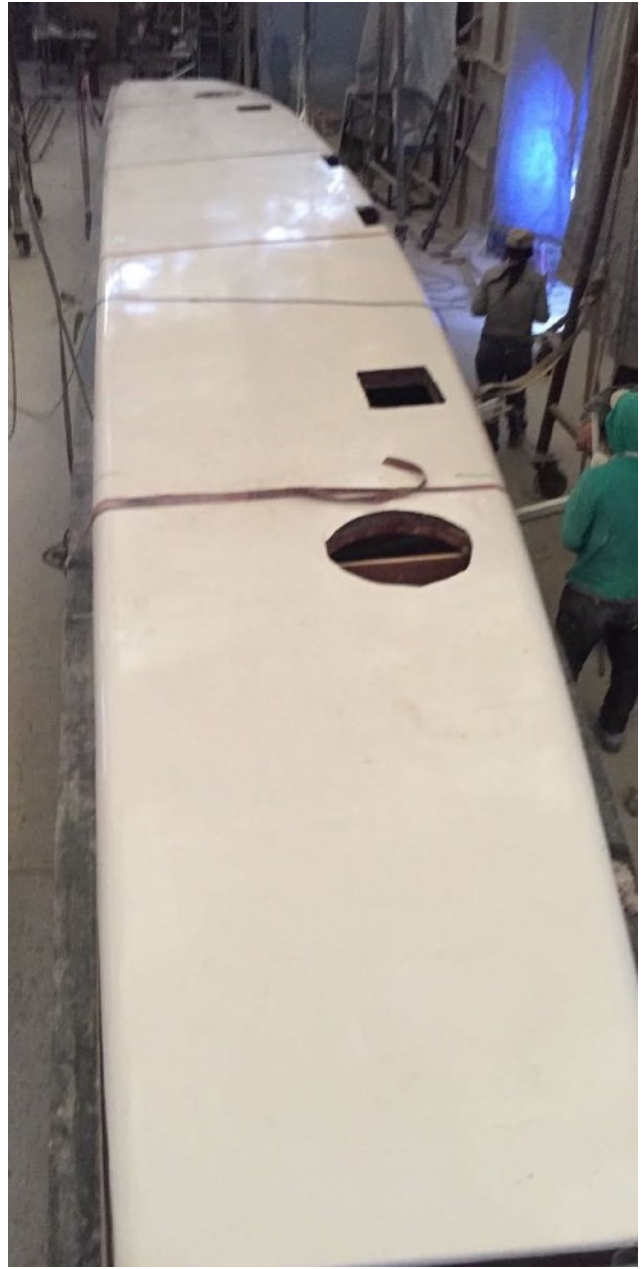
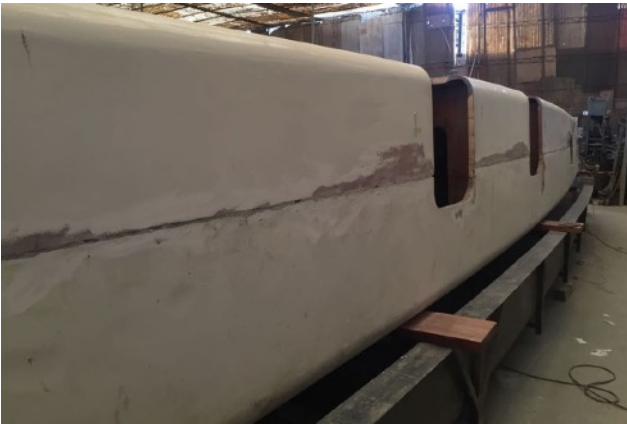
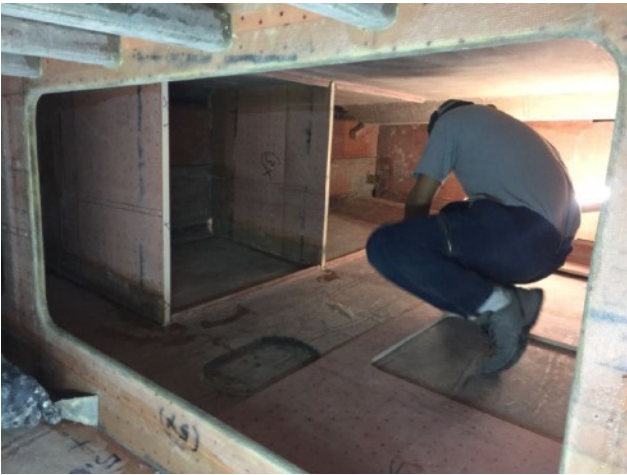
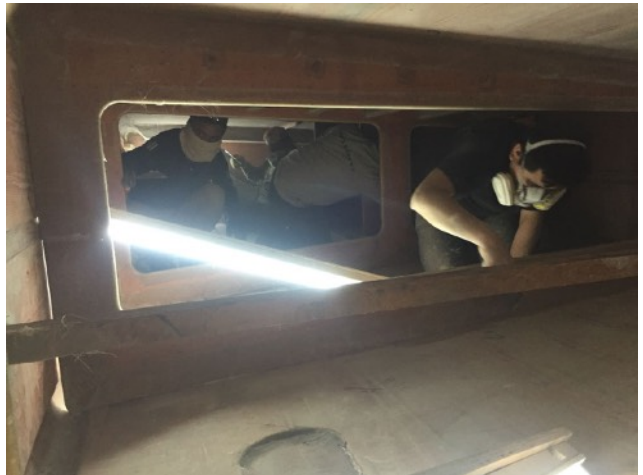
“Because of the short gel time of the glue, we had to get the job done in 30 minutes. We were 8 inside the hull with spatulas + 2 running boards with mixed material to them + 2 pouring from the gun onto the boards + 4 ready to drop down the hull from cranes as soon as advised + 2 calling the instructions.”

Pretty stressful and fortunately they are well organised. Next time, a longer gel time will be selected. However, the result is that the hull is now in one piece, with all the bulkheads in place, with no coving or wet laminate required, saving several weeks of sticky work, plus several more of sanding to fair the tabbing.
